## AN INDOOR AIR QUALITY EVALUATION WITH EMPHASIS ON FUNGAL CONTAMINATION

**Project:** Joseph Paneky Center  
13700 Cantrell Road  
Little Rock, Arkansas 72212

**Date of Inspection:** July 31, 2014

**Date of Report:** August 8, 2014

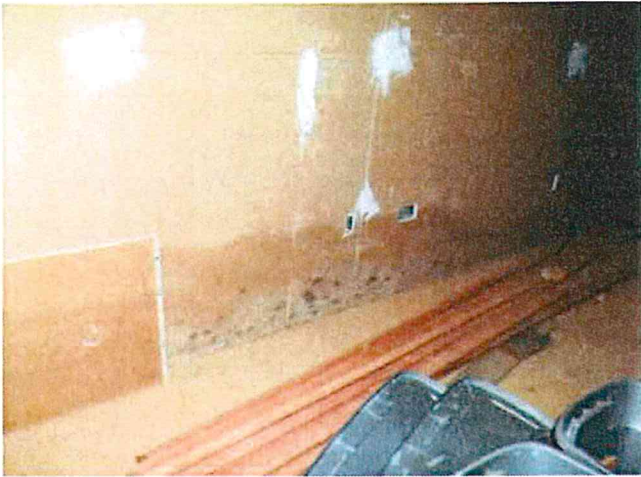
EMTEC's visual inspection of the interior of the building revealed evidence of water infiltration, water damage and fungal growth. The water infiltration was evident by the amount of outside dirt on the exposed concrete slab, as well as the water staining on all the sheetrock walls. Fungal growth was present on several of the sheetrock walls, specifically located on the bottom two feet of the sheetrock walls.

FUNGAL GROWTH ON NORTH WALL OF SPECIAL  
EVENT ROOM

- Remove and dispose of the bottom four feet of all interior sheetrock walls.
- Remove and dispose the bottom four feet of any wall insulation.
- Thoroughly sanitize all exposed (behind the removed four feet of sheetrock) wall studs and bottom plates, ensuring all fungal growth has been removed. Please note, sanding of these wall studs and bottom plates may be necessary to remove any fungal growth.

- Seal all of the exposed wall studs and bottom plates (behind the removed four feet of sheetrock) with kilz.
- Perform post remediation inspection and possible re-sampling.

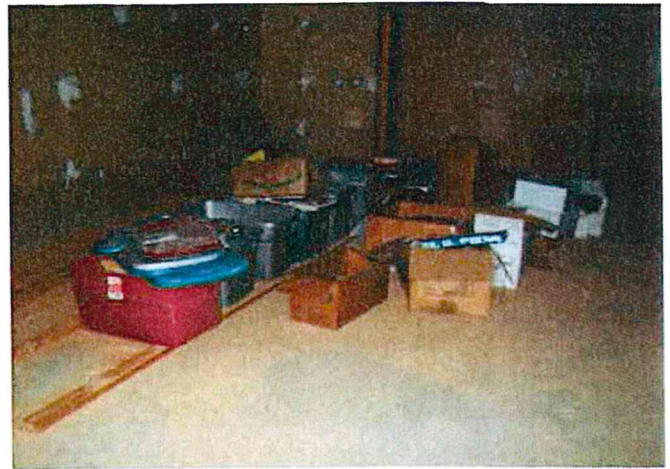
FUNGAL GROWTH ON NORTH WALL IN SPECIAL  
EVENT ROOM-

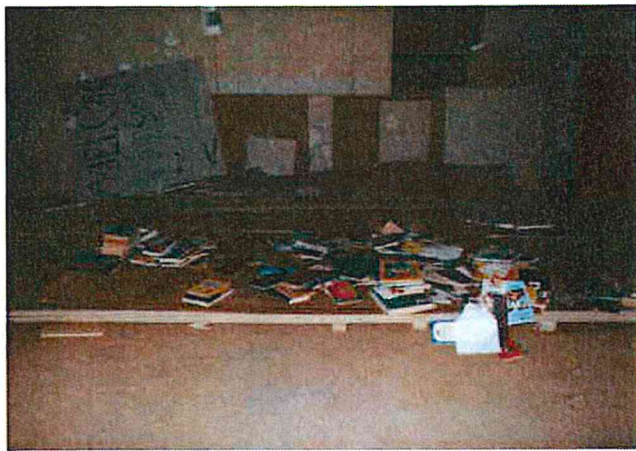
MATERIALS IN LUNGE AREA OF BUILDING

- Place at a minimum five air scrubbers within the building, all venting to the exterior. Additional access to power will have to be addressed.
- Remove and dispose of all construction materials, miscellaneous contents and dirt on the concrete floor from the building except for the following:

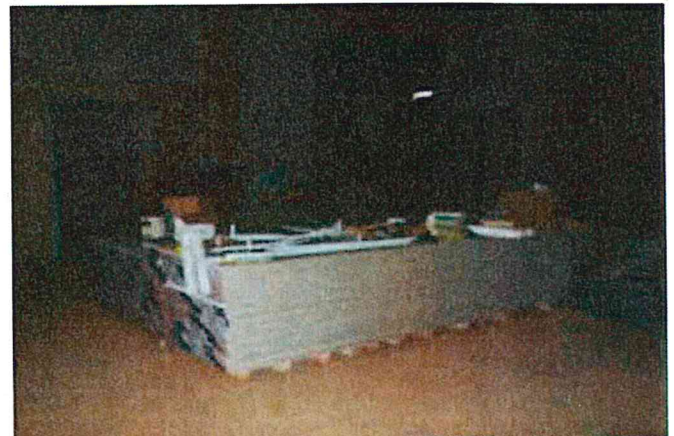
BUILDING MATERIALS IN SPECIAL EVENT ROOM

1) Stack of sheetrock in the Main Event Room. Please note, the bottom few sheets will need to be thoroughly inspected for any fungal growth. If fungal growth is present, then those sheets of sheetrock should be disposed.

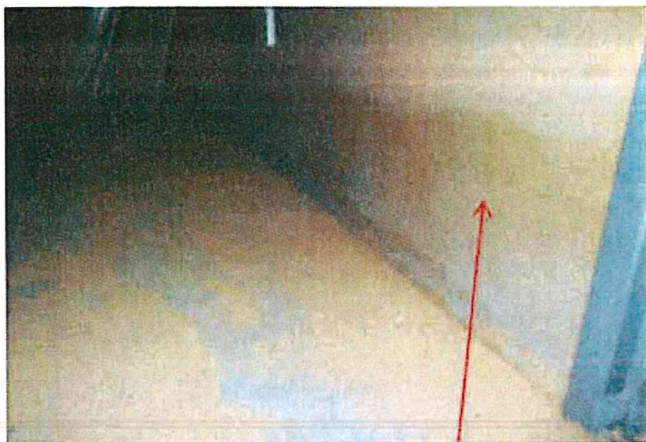
WATER STAINING AND FUNGAL GROWTH ON  
SHEETROCK WALL

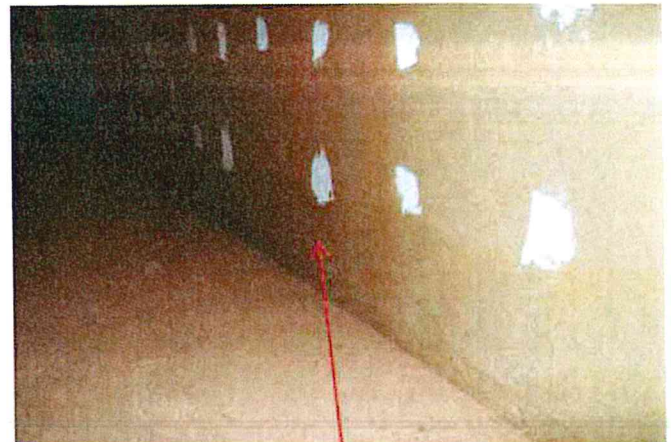
WATER STAINING AND FUNGAL GROWTH ON  
SHEETROCK WALL

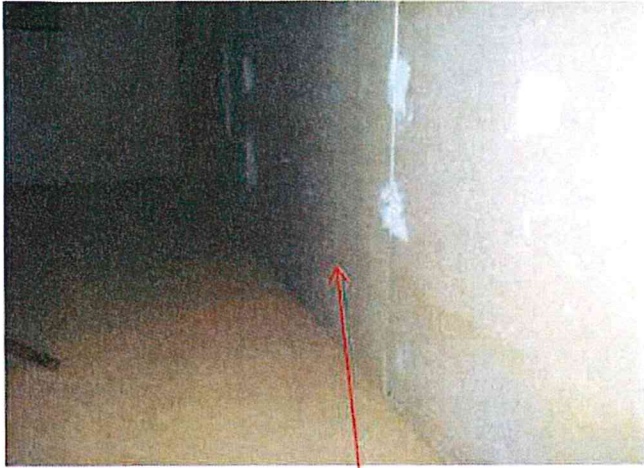
WATER STAINING AND FUNGAL GROWTH ON SHEETROCK WALL

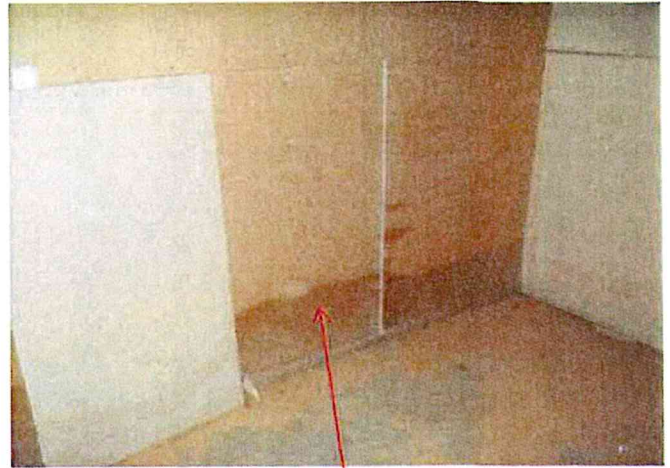
WATER STAINING AND FUNGAL GROWTH ON SHEETROCK WALL

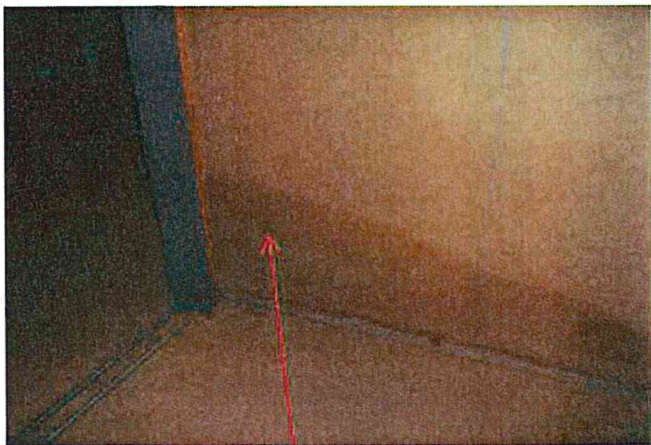
WATER STAINING AND FUNGAL GROWTH ON SHEETROCK WALL

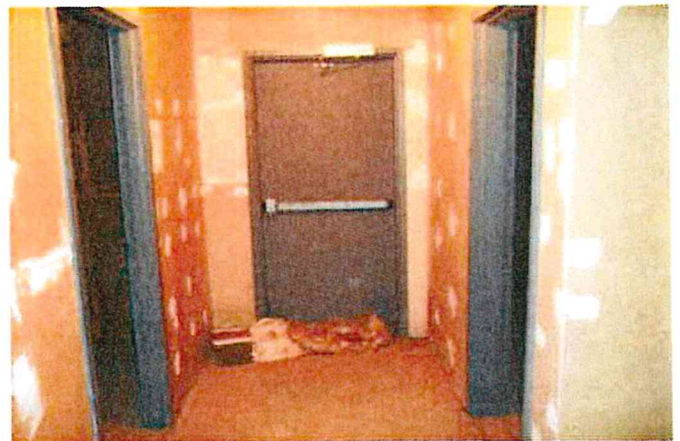
Although the interior of the building has not been finished, it still contains construction materials, such as sheetrock, etc. The interior of the building has also been utilized as a storage area containing several totes and containers of books and miscellaneous items. During the evaluation, Mr. Fabian Marks informed the EMTEC team that the building has sustained some water infiltration over the years, all stemming from the east exterior door in addition to some roof leaks.

EAST EXTERIOR DOOR-SOURCE OF WATER INFILTRATION

- Ensure that all water infiltration has been properly addressed and corrected: including, but not limited to, any roof leaks and all water infiltration from exterior doors or any other portions of the building.

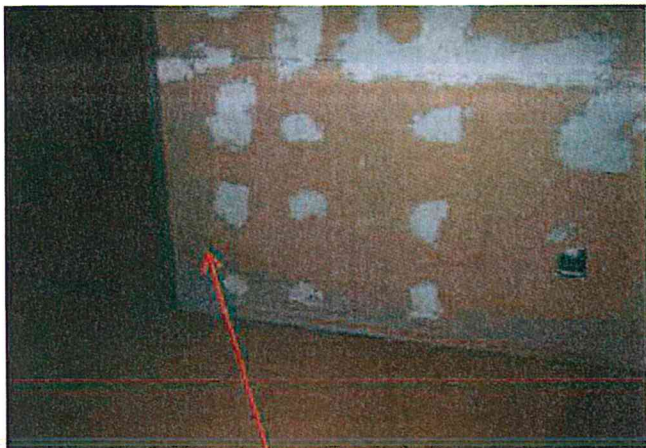
WATER STAINING AND FUNGAL GROWTH ON SHEETROCK WALL

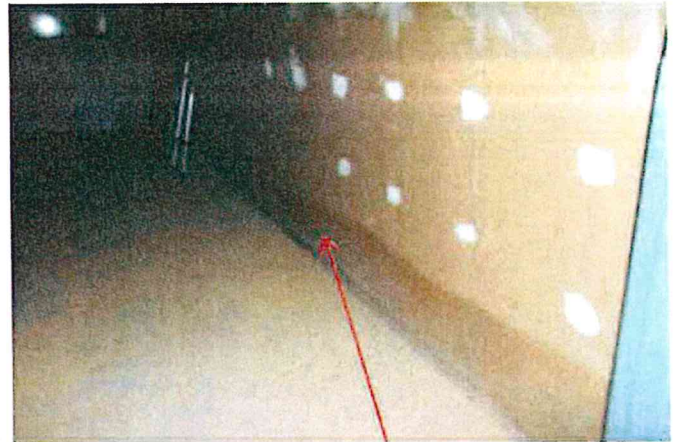
WATER STAINING AND FUNGAL GROWTH ON SHEETROCK WALL

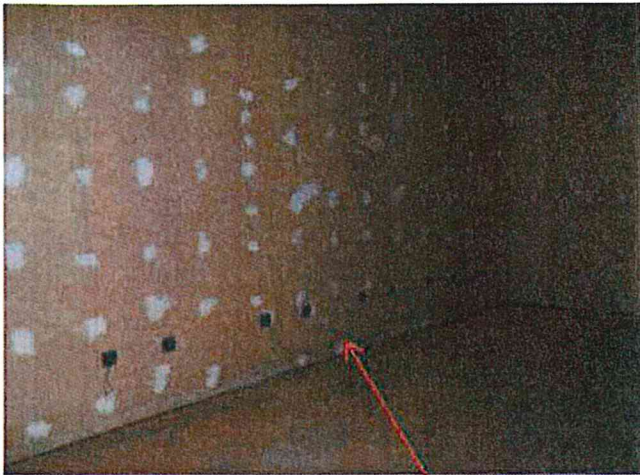
WATER STAINING AND FUNGAL GROWTH ON SHEETROCK WALL

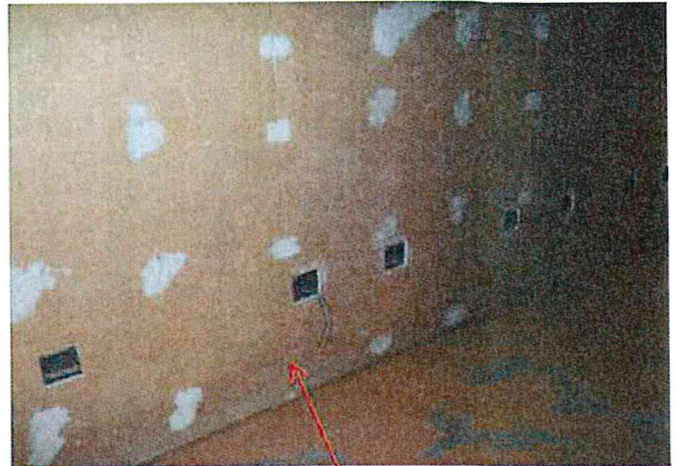
WATER STAINING AND FUNGAL GROWTH ON SHEETROCK WALL

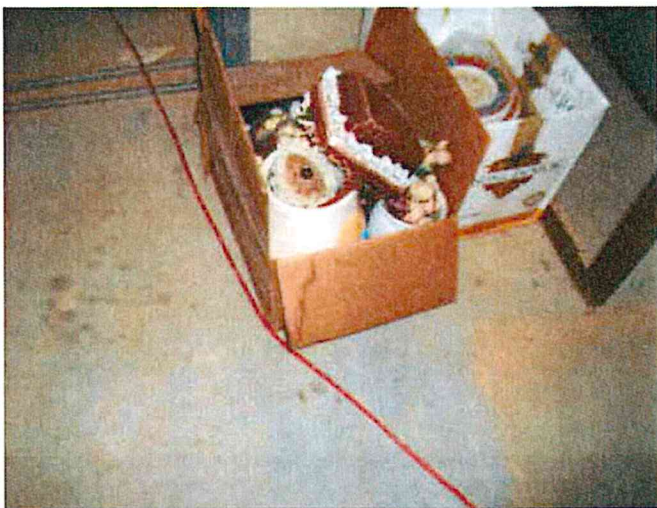
BOXES/ITEMS IN SPECIAL EVENT ROOM

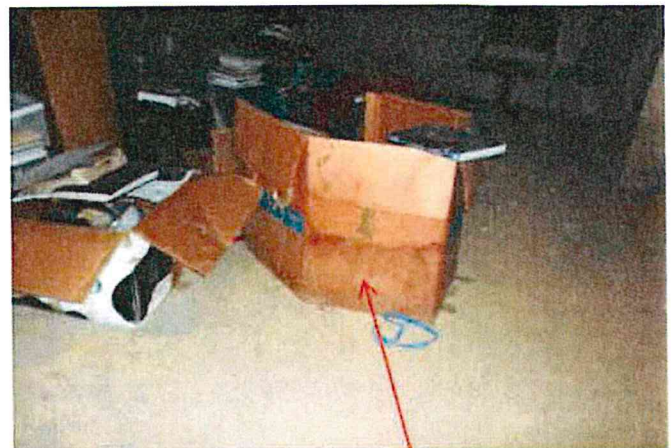
BOXES/ITEMS IN SPECIAL EVENT ROOM-NOTE  
WATER DAMAGE ON FUNGAL GROWTH

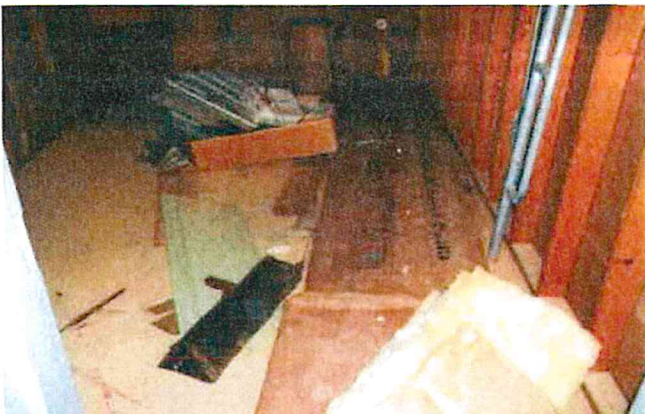
CONSTRUCTION MATERIALS ON GROUND-NOTE  
WATER DAMAGE AND FUNGAL GROWTH
